1998 Debris Flows near the Yakima River, Kittitas County, Washington—Some Geomorphic Implications

Martin R. Kaatz, Professor Emeritus
 Department of Geography and Land Studies
 Central Washington University; Ellensburg, WA 98926
 e-mail: marcar@elltel.net

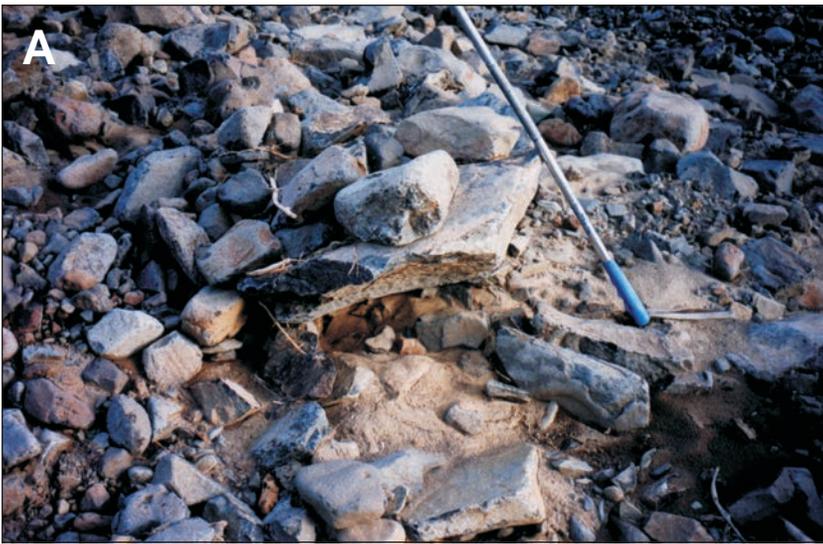
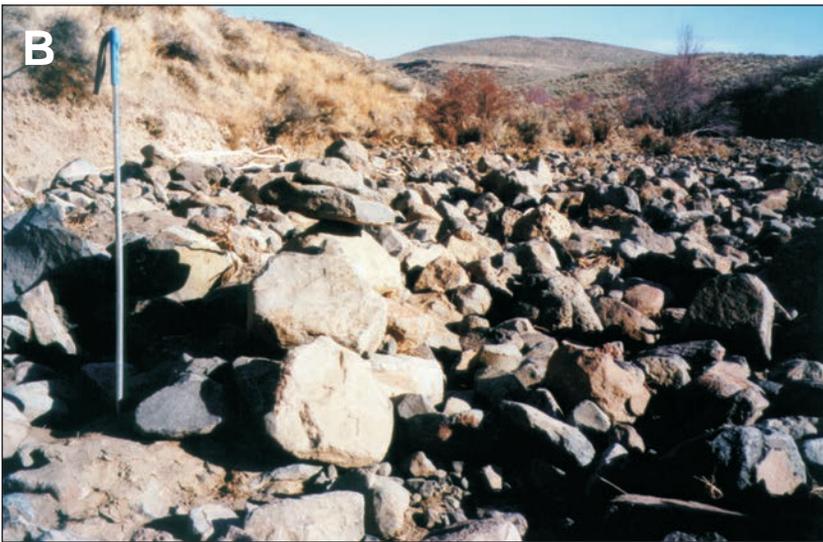
Figure 2. A. Imbricated rock in debris channel in lower McPherson Canyon. Note the size of the material entrained. B. Perched boulders a short distance downstream from A. C. Upended slab left by waning flow.

and intermittent lobes of cobbles and boulders were typical. Fresh percussion marks on rocks testified to the force with which some of the entrained rocks struck one another. Debris suspended on bankside shrubs indicated that some flows had depths greater than 6 feet (1.8 m). Debris levees formed intermittently along channel flanks. Lobes of debris occurred wherever the velocity was so diminished that the slurry conveying the debris could no longer maintain its momentum. Deposition was especially favored where channel gradients and channel confinement or constriction lessened significantly. Some of the rock deposits show imbricate bedding, a few with basalt slabs a foot (30 cm) or more in diameter. Here and there, rocks remained perched precariously after their supporting slurry drained away (Fig. 2).

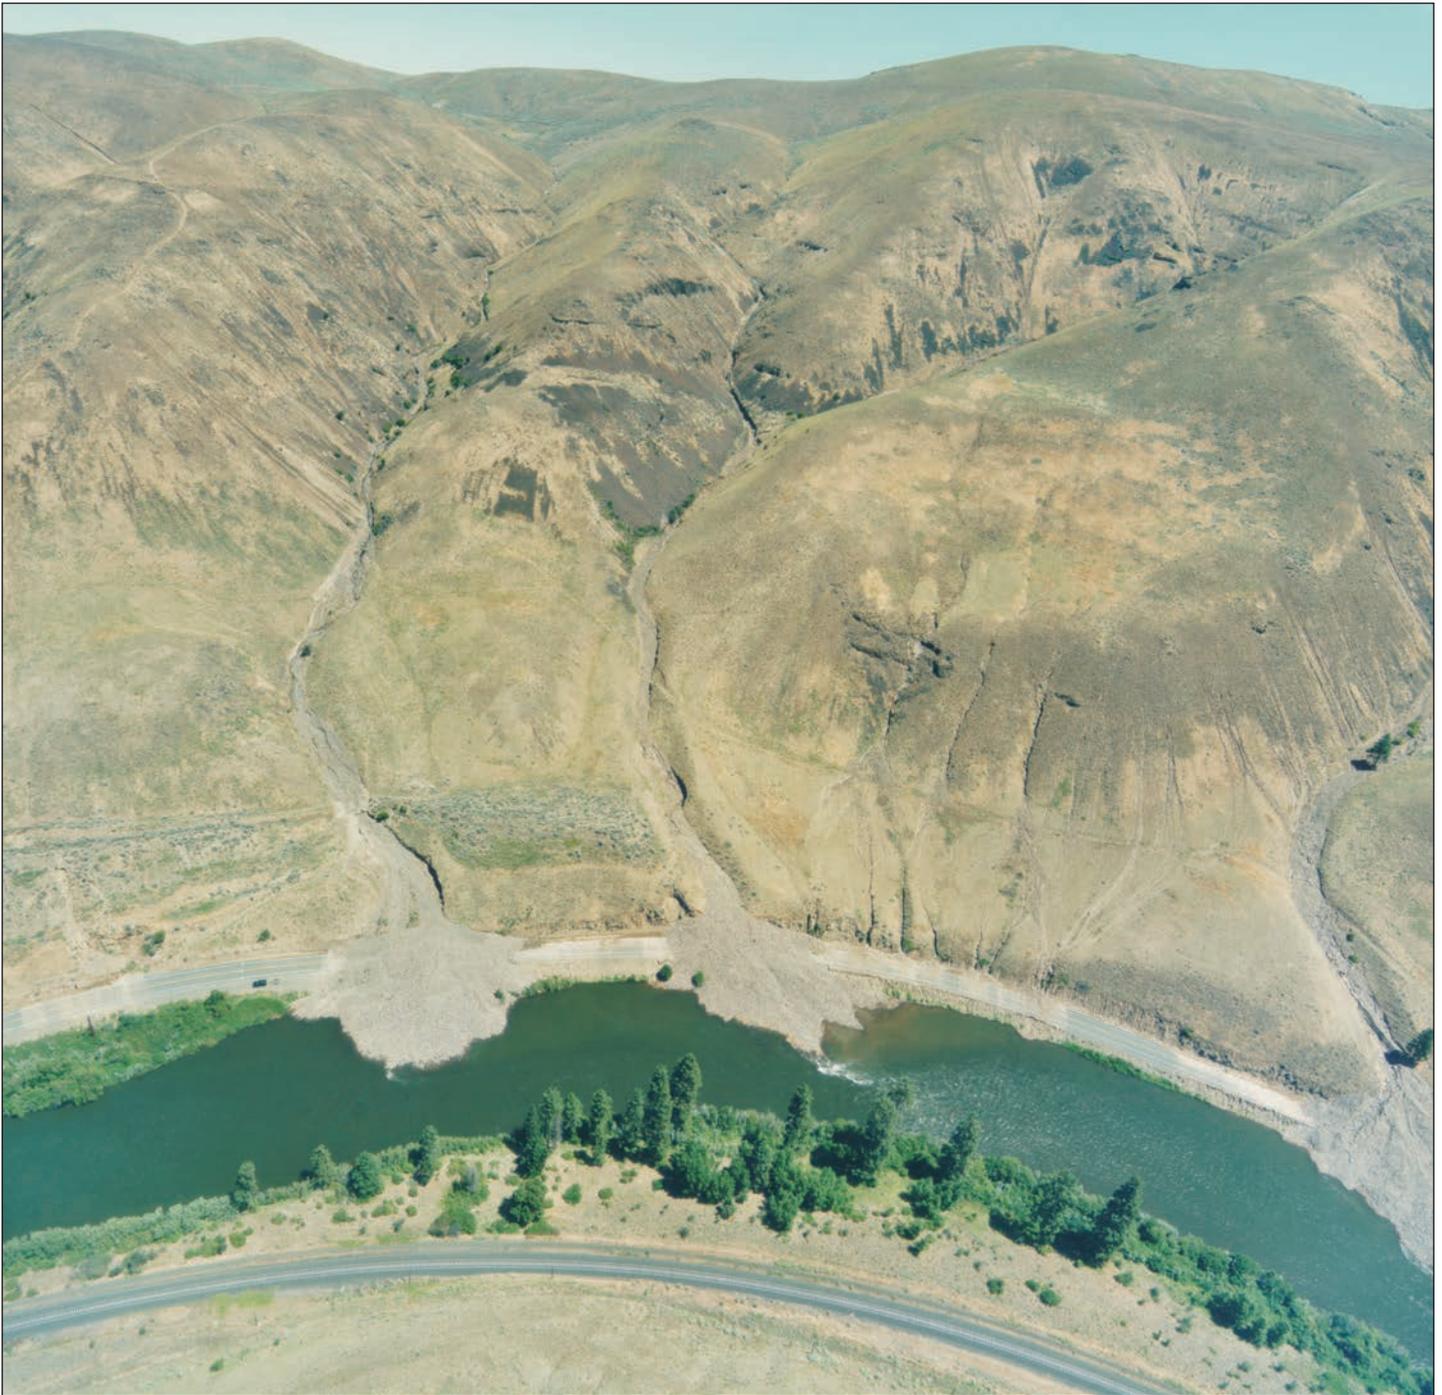
Figure 3. Debris flows along the north side of Beavertail Bend of the Yakima River burying State Route 821 and debouching into the river. Note the small catchment areas of the ravines and their steep scoured channels. *Photo courtesy of the Washington State Department of Transportation.*

Ravines draining westward from the southwest flank of Manastash Ridge directly into the Yakima River canyon discharged rocky debris that quickly buried portions of State Route (SR) 821, depositing debris fans into the adjacent river channel. The deposits generally lie downstream of the principal precipitation catchment area. Every ravine abutting SR 821 between mileposts 19 and 23 (Fig. 1), a straight-line distance of about 2.6 miles (4.2 km), was affected to some degree by the torrents. Major debris deposits covered SR 821 in eight separate places between mileposts 19 and 21 opposite Beavertail Bend. Six reached well into the river. One of these buried the highway with debris more than 15 feet (4.6 m) deep and continued nearly 60 percent of the way across the river channel (Fig. 3). The ravines, all less than one mile (1.6 km) long,

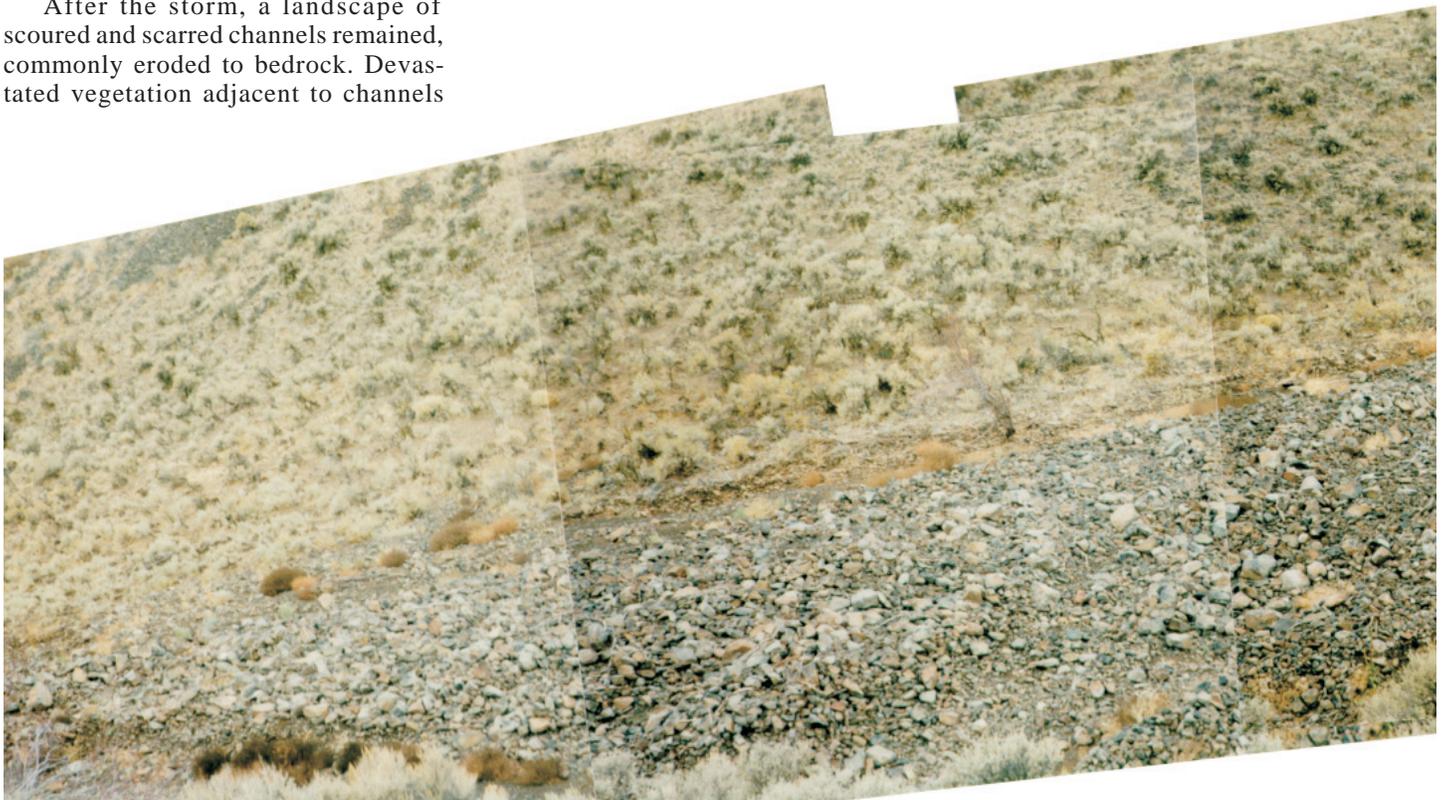
Figure 6. (preceding page and bottom, this page) Debris lobe at the confluence of the unnamed western tributary, upper right, and the main McPherson Canyon channel in the foreground.

A very large lobe of rocks (Fig. 6) was deposited by the debris flow where the western tributary joins the main channel of McPherson Canyon. Its volume and size approximates that of the largest of the deposits, estimated to be 50,000 cubic yards (38,227 m³) in volume and more than 15 feet (4.5 m) deep, that flowed onto SR 821 near milepost 20 (Fig. 3). A widening of the valley floor, a decrease in channel gradient, and a change in channel direction combined to decrease flow velocity and deposit the debris lobe at the confluence.

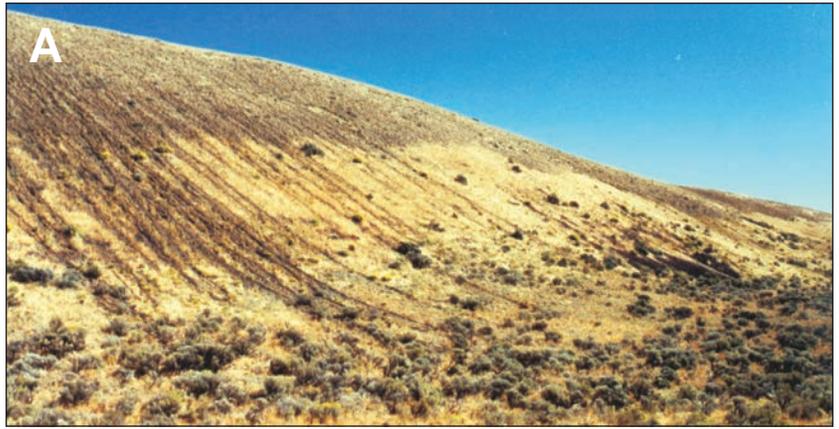
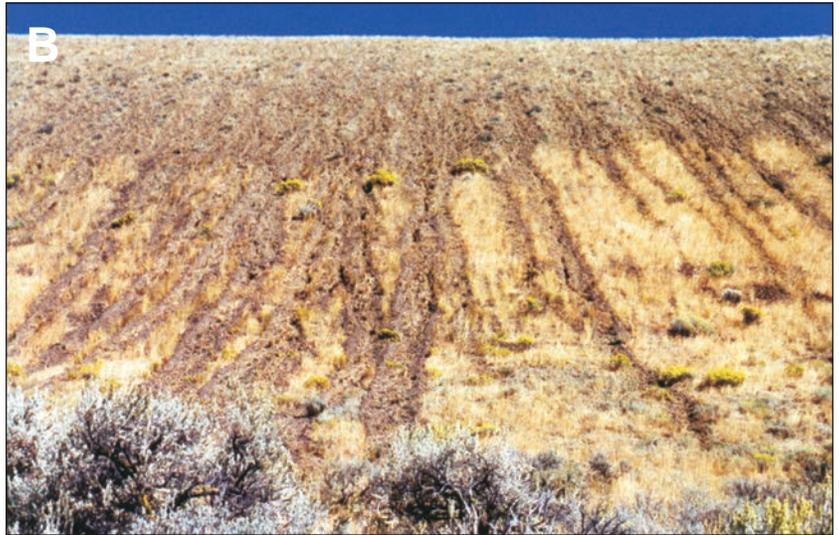
Figure 5A and B. (top and middle, this page) Streaked southwest flank of Manastash Ridge following the July 1998 storm. The streaks are furrows eroded through the loess (silt) mantle down to bedrock. Photo courtesy of Will Johnson.

terspersed with sparsely vegetated strips (stone stripes) extend downslope (Fig. 5). This loose rock and loess, augmented with debris gathered by sheetwash and rilling on the ridge's mid flanks, was the initial source of storm-delivered sediment to first-order channels of McPherson Canyon. The slurry that formed from the sediments had the velocity needed to entrain cobbles and boulders up to about 1.5 feet (0.5 m) in diameter (Fig. 3). Most of the discharge of water, entrainment of debris, and erosion occurred in the western tributary to McPherson Canyon. Only the upper portion, about one square mile (2.6 km²), of the tributary's watershed was entirely within the catchment area.

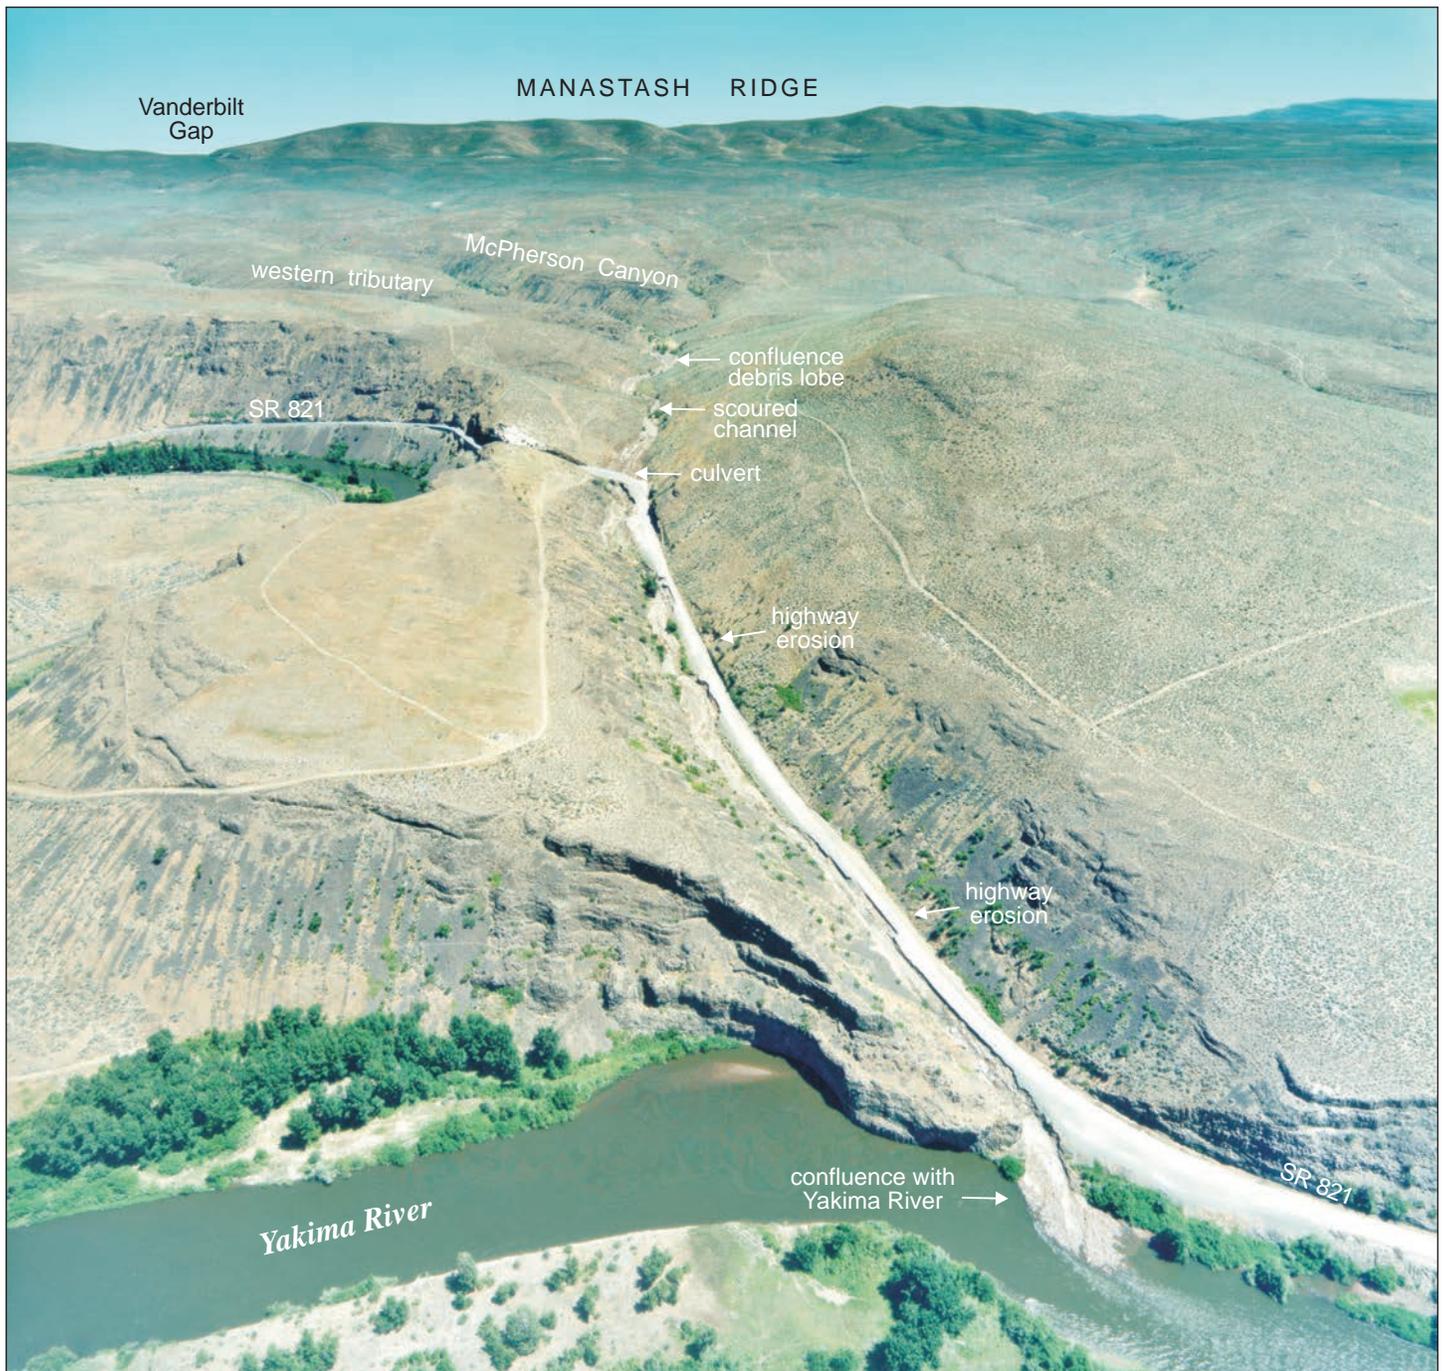
Figure 7. Looking northeast from the mouth of McPherson Canyon to the summit of Manastash Ridge. Note the scoured channel between the highway crossing of McPherson Canyon and the confluence debris lobe. Erosion from the overflow of the culvert can be seen paralleling the highway downstream to the Yakima River. The catchment area for the debris flow in McPherson Canyon lies beyond the left side of the photo (Fig. 4). Photo courtesy of the Washington State Department of Transportation.

The channel discharge that followed the loss of load at the confluence caused extensive downstream erosion and highway damage (Fig. 7). The now-more-liquid slurry was able to speed downstream, relatively unencumbered, to a culvert beneath SR 821. It overwhelmed the culvert and turned the highway embankment above the culvert into a 150-foot (46 m)-wide dam, temporarily ponding the surging water for a distance of 700 feet (220 m) upstream. When the impounded water overtopped the embankment barrier, it eroded a double cataract into the pavement where it plunged back into its channel adjacent to the highway's southbound lane. Other segments of the road were undermined as the flood continued down the channel to its confluence with the Yakima River. Subsequently, a narrower, deeper channel trenched this reach, a response to at least one last surge of essentially debris-free water.

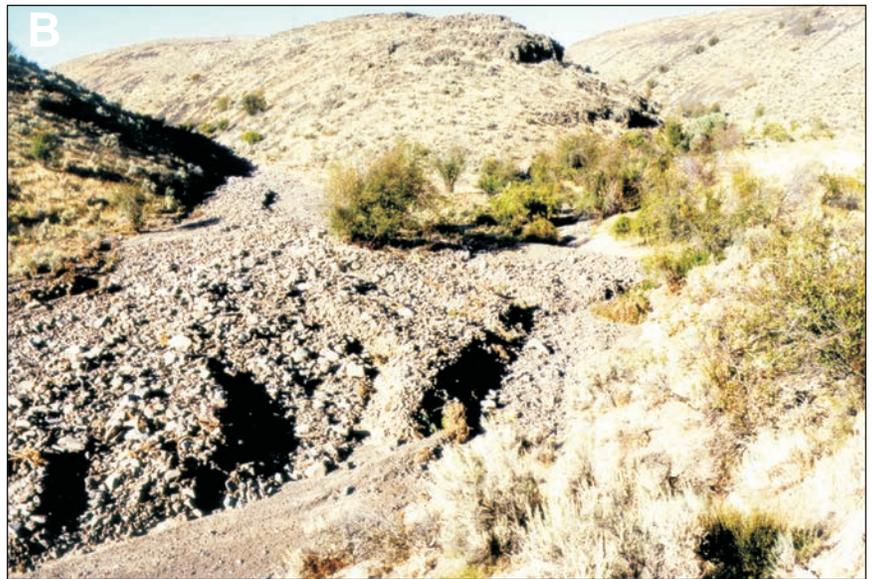
Figure 8. A. Toe of the confluence debris lobe showing incision by flooding following initial deposition. B. Incision on debris lobe south flank. The western tributary, the source of virtually all of the debris, is on the upper left; the main McPherson Canyon channel is on the upper right.

subsequent flow down only the western tributary deposited the debris lobe. (3) A final(?) flow down the western tributary continued to the outlet of McPherson Canyon. The debris lobe is scarred by at least three gullies (Fig. 8) partially incised into its distal flank, suggesting that the lobe was overtopped after its initial deposition.

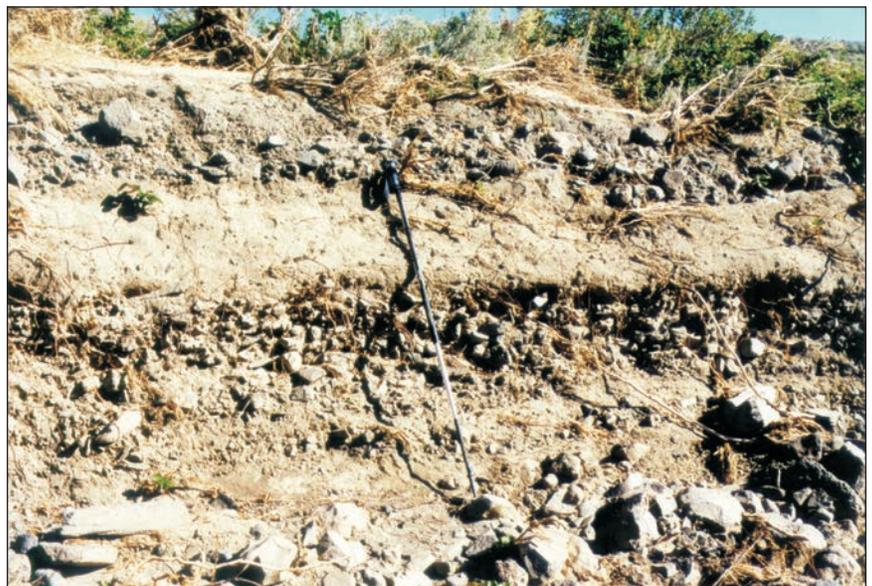
Figure 9. (right) Stratigraphy of alternating cobbles and fines in incised channel of the western tributary indicates the occurrence of previous debris flow events.
