LiDAR Assessment of Sediment Transport Related to the Removal of the Marmot Dam, Sandy River, Oregon

LIDAR ASSESSMENT OF SEDIMENT TRANSPORT RELATED TO THE
REMOVAL OF THE MARMOT DAM, SANDY RIVER, OREGON

In Partial Fulfillment
of the Requirements for the Degree
Master of Science
Geology

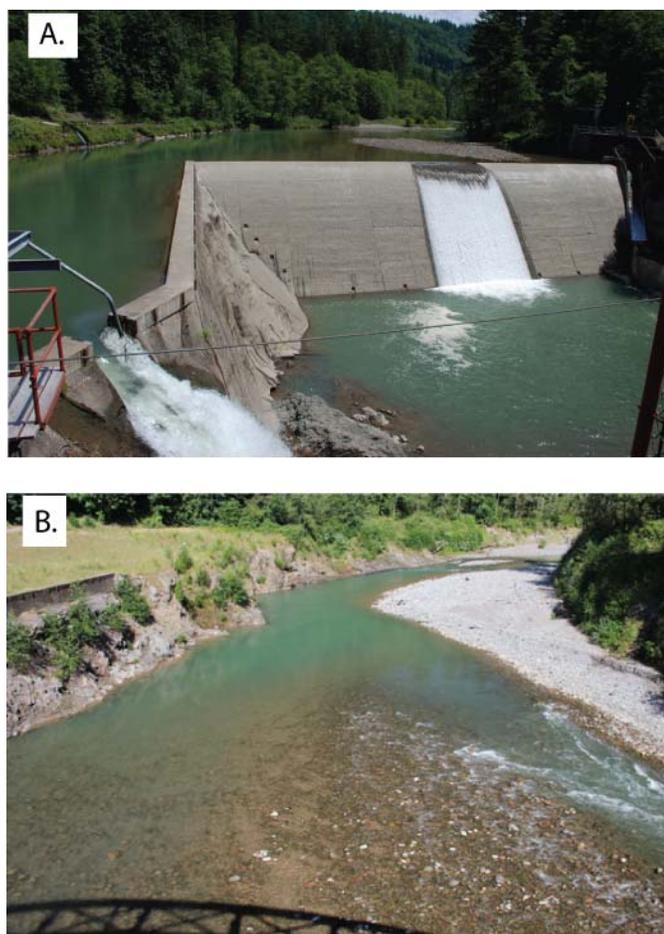
Figure 1: Images of Marmot Dam before and after removal. A: Former Marmot Dam, photo taken in 2007 (photo courtesy of Portland General Electric). B: Site of the former Marmot Dam site in the foreground, looking upstream toward the emptied reservoir in the background (photo taken by Carl Matzek)

In October 2007 the Marmot Dam on the Sandy River, Oregon (Figure 1) was removed releasing 438,000 m³ of the estimated 750,000 m³ of impounded sediment into the river reach downstream of the dam (Major et al. 2011). Prior to and after the removal of this dam, a collaborative effort among multiple government and private agencies allowed for an unprecedented collection of data, including repeat total-station surveys of

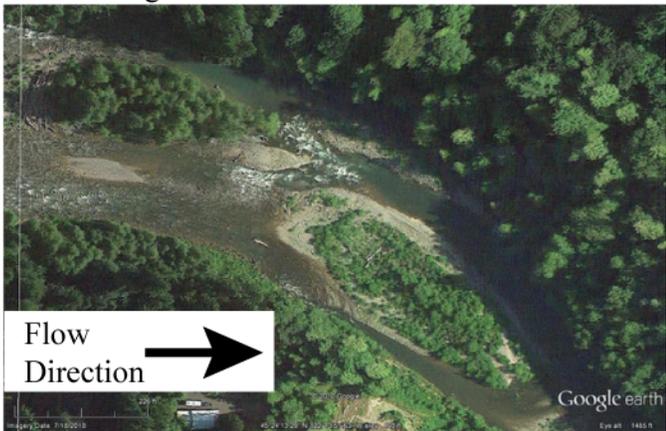
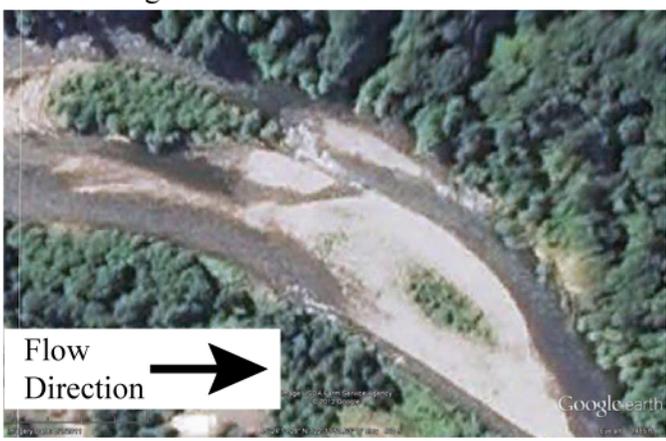
Figure 15: Google Earth images of the first sediment bar downstream from mouth of the gorge. Top image is from 2010 before a large flood and bottom image is from 2011 after the large flood.

A fair amount of erosion occurred within the Below Dam Reach during 2008-2010, and this sediment probably passed through the gorge and was deposited on the first bars downstream, at the upstream end of the Gorge to Bull Run Reach (Table 2; Figures 8 and 9). The absence of new sediment in the 2008-2007 DoD followed by deposition after the 2008 LiDAR survey is interpreted as a sediment pulse related to the removal of the dam and propagating downstream over the course of 2 years. Downstream of the first 2 km in this reach, the sediment pulse could not be distinguished from sediment that was reworked by normal river processes. The influx from the dam removal might have extended farther downstream, but it was overwhelmed by the background of natural sediment transport in the river. In the DoD images farther downstream within the Gorge to Bull Run Reach there is no sudden appearance of a large volume of sediment equivalent to that at the upstream end of the reach. Repeat ground surveys between 2008 and 2009 (Bauer, 2009; Podolak, 2011) were unable to detect any change in the river channel related to the dam removal downstream of Revenue Bridge (Figure 3). The lack

of evidence during the ground survey suggests that the sediment pulse entered the reach during the high flows during the winter of 2010, nearly 3 years after the removal of the Marmot Dam.
